AGARD Corrosion Handbook
Volume 1:
Aircraft Corrosion: Causes
and Case Histories

AGARD CORROSION HANDBOOK

AIRCRAFT CORROSION: CAUSES AND CASE HISTORIES

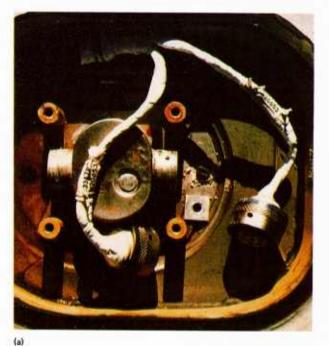
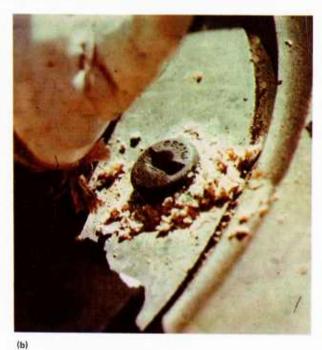
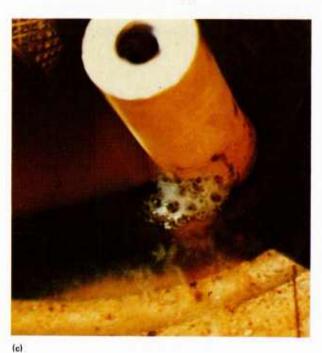
The need to prevent the ingress of water and other corrodents to internal structure and equipment is nowhere more important than with electrical and avionics equipment. In the interests of obtaining specific electrical characteristics, the materials used are often inferior in terms of corrosion resistance, and serious corrosion problems and often malfunction of equipment can occur if the equipment is not properly sealed. Figure 7-6(a-c) shows examples of corrosion of electrical equipment in a military aircraft due to water intrusion around the access door. The general reddish-orange discolouration of the compartment walls and floor, in Figure 7-6(a), indicates that uniform corrosion has occurred in these areas. The close-up photographs of Figure 7-6(b) and -6(c) show local eruptions of corrosion products around a screw and binding post, which are probably examples of galvanic corrosion and crevice corrosion.

Fig. 7-6 Corrosion in a container used to house electrical equipment

- (a) Discolouration indicates general corrosion of the walls and floor of the compartment.
- (b) Localized corrosion around a screw
- (c) Localized corrosion at the base of a binding post.

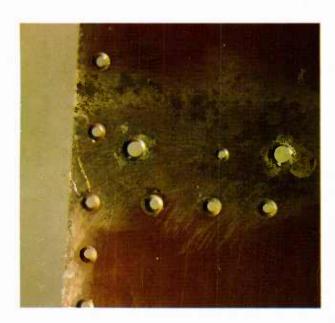
The example of Figure 8-2 shows dissimilar metal, or galvanic corrosion damage at fastener holes where steel bolts fastened through a magnesium alloy skin. The positions of these two materials in the electrochemical series, or galvanic series indicates that a high electrochemical potential would exist between them when in contact, and severe galvanic corrosion could be expected to occur.

Fig. 8-2 Galvanic corrosion around fastener holes used to locate steel fasteners in a magnesium alloy skin

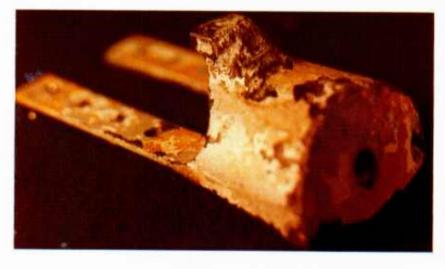
Fig. 9-1(b) Severe pitting in a cast magnesium alloy stringer end cap

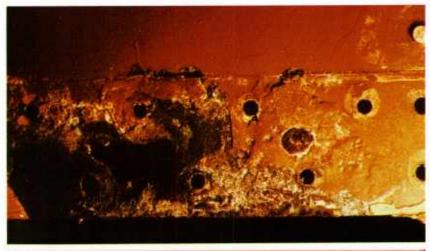
(a) Dismantled joint in a magnesium alloy panel.

Some examples of crevice corrosion are shown in Figures 9-2(a), 9-2(b) and 9-2(c). Figure 9-2(a) shows a corroded and perforated magnesium panel in a dismantled joint area from a transport aircraft structure. The corrosion damage was due to inadequate sealing. Figure 9-2(b) presents a similar case of crevice corrosion at the interface of a magnesium alloy skin joint, which was also due to inadequate sealing. In both examples the most severe damage is away from the edges of the fastener holes which suggests that galvanic corrosion was not the major factor. Figure 9-2(c) shows a situation where both galvanic corrosion and crevice corrosion contributed to the damage. The corrosion damage has occurred at the junction between a magnesium alloy floor panel and aluminium alloy frames and angle plates. This problem was probably aggravated by poor drainage conditions, and inadequate sealing and surface protection.

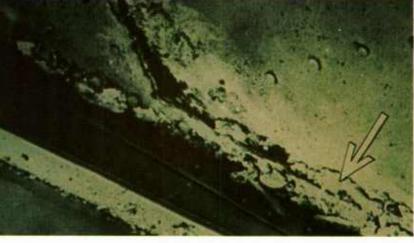
(c) Crevice and galvanic corrosion between a magnesium alloy floor panel and aluminium alloy frame member.

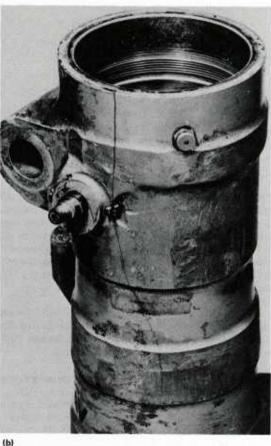
Stress corrosion is a particularly insidious form of corrosion since it will often occur with little or no visual evidence of surface corrosion such as discolouration or the build up of noticeable corrosion products. This is illustrated in Figure 13-1(a), which shows stress corrosion cracking in the bosses of a forged aluminium alloy component. The cracks can travel over long distances with time, as indicated in Figure 13-1(b), and as they propagate they lower the residual strength of the affected part. Figure 13-1(b) shows stress corrosion cracking which initiated at corrosion pits in the flat lower surface of an undercarriage leg, the corrosion pits having served as local stress raisers. Stress corrosion cracks may propagate deeply into thick section parts, as indicated in Figure 13-1(c), while the visible surface crack length may often be quite small. The banded appearance of the fracture surface in Figure 13-1(c) is an indication that crack growth occurred in a slow, time dependent manner, and macroscopically the fracture surface may resemble

- Cracks in the bosses of a forging.
- SCC in an undercarriage leg. Stress corrosion fracture surface in an aluminium forging.

Fig. 13-1 Examples of stress corrosion cracking in aluminium alloy components

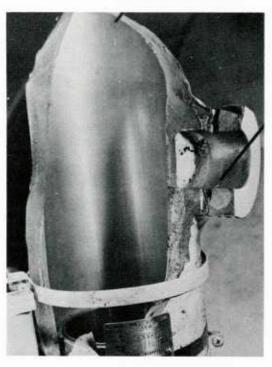
The nose landing gear strut of a fighter aircraft failed during a normal landing procedure after only 30 hours of flight had been accumulated. The failed part is shown in Figure 13-35, and closer examination of the fracture surfaces evident in the failed part revealed that pre-existing cracks had been present prior to the final failure. The fracture surfaces due to these pre-existing cracks are shown in Figure 13-36, and it can be seen that these had initiated at the corners of the bore holes used to locate the clamping attachment bolts for the retraction cylinder.

BORE OF THE CLAMPING ATTACHMENT BOLT FOR THE RETRACTION CYLINDER

Fig. 13-35 Stress corrosion cracking in a 7075-T6 nose landing gear strut, case history 13-7.

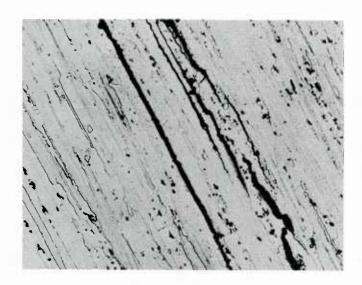
Figure 13-41 shows a metallographic section normal to the LT direction and cracks can be seen running in the longitudinal direction along grain boundaries. The fracture surfaces were corroded, and in most cases they showed no recognizable feature other than flat grain boundary surface facets, as shown in Figures 13-42(a) and 13-42(b), and secondary cracking (Fig. 13-43). In a few cases striation like markings were present immediately adjacent to the fastener holes and in most cases the surfaces of the fastener holes contained corrosion pits. The failure analysis report made no mention of sealants or other forms of corrosion protection in the fastener holes and no information was given on the fastener materials used. However it was concluded that cracking was due to stress corrosion, initiating at corrosion pits in the bore of the fastener holes. The stresses were believed to be due to assembly and operating loads and a stress analysis showed that stresses in the ST direction in the region of the fastener holes were in excess of the threshold values for stress corrosion cracking given in Reference 13-1, Table 13-1.

Fig. 13-41 Metallographic section indicating the intergranular crack path in the fuselage frame, case history 13-8.

It was recommended to replace these fuselage frames with 7075-T73 to prevent SCC. However, since there was evidence of fatigue in some areas and since threshold stress intensities for fatigue in 7075-T73 are slightly lower than for 7075-T6 it might be preferable to replace this alloy completely with a higher strength stress corrosion resistant alloy such as 7050-T73. Wet assembly of fasteners should also assist by excluding moisture from the fastener holes.

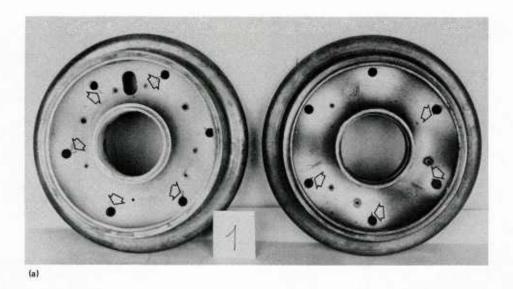
Multiple cracks were found propagating out of bolt housings during a visual and liquid penetrant inspection of the nose wheels of a fleet of fighter aircraft. Many wheels were found to be affected, and typical cracks are indicated by the arrows shown in Figure 14-10(a).

Several cracks were opened in the laboratory, and these showed a dark zone, covered by corrosion products, which extended up to the bright overload zone produced during opening (Fig. 14-10(c)). The inner surfaces of the bolt holes were also examined. These were found to contain deep corrosion pits of the type shown in Figure 14-10(d). Examination of the fracture surfaces using a scanning electron microscope showed that intergranular cracking had occurred in the initiation regions (Fig. 14-10(e)), while transgranular fracture had occurred at longer crack lengths (Fig. 14-10(f)). Both the intergranular and transgranular zones were badly corroded, but fatigue striations were clearly visible in the transgranular areas (Fig. 14-10(f)).

Pitting attack in the bolt holes may have been influenced by galvanic effects, or by crevice conditions existing between the wheel and the steel bolts. However, the presence of heavy corrosion across the fracture faces and the clear evidence of striations suggests that corrosion fatigue was responsible for at least the later stages of crack propagation. This aircraft had operated in the Mediterranean region which is also a significant factor. This, and the two preceding case histories, suggest that magnesium alloy castings are not good choices for aircraft wheels.

Fig. 14-10 Corrosion fatigue of a magnesium alloy (AZ-91C) nose wheel

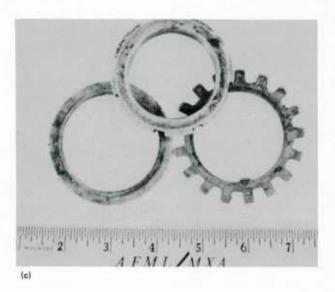
Fig. 14-15 Corrosion fatigue of a 4340 steel rotor attachment assembly

Visual examination revealed that the hinge pin was broken, and the fracture face showed a flat beach mark indicating the presence of a pre-existing crack. The fracture surface and beach mark are shown in Figures 14-15(d) and 14-15(e) respectively. Also noteworthy was a dent on one side of the threaded area of the hinge pin (Fig. 14-15(f)). The threaded area was examined carefully to determine whether the nut was on the pin at the time of the crash. The nut was not recovered.

- (a) Threaded end of the horizontal hinge pin with arrows indicating fracture location.
- Mating part of the hinge pin with arrows indicating fracture location.
- (c) Nut and locking washer from the failed pin.(d) Fracture face of the pin before cleaning.

Optical examination of the hinge pin showed the beach mark or pre-crack had progressed across about one quarter of the total cylinder cross-sectional area. Further examination of the hinge pin close to the fracture initiation site revealed the presence of corrosion pits and secondary cracking on the outer circumference of the pin adjacent to the primary fracture face. The cracks ran parallel to the primary fracture and seemed to be propagating from small pits (Fig. 14-15(g)).

The failure of the horizontal hinge pin was attributed to corrosion fatigue. The failure initiated in areas of localized corrosion pits, and propagated by fatigue to the depth indicated in Figure 14-15(e). The 4340 steel was found to have a hardness of $R_{\rm c}$ 41, which was within the specified range of $R_{\rm c}$ 39-43 for this part, and the part was found to be cadmium plated. As noted in Chapter 9, 4340 steel has poor corrosion resistance and corrosion protection is required in most normal operating environments. The presence of pitting in the hinge pin suggests that the cadmium plating had deteriorated to expose the underlying steel.

It was noted that the rotor assemblies were more than 11 years old, and a complete inspection and overhaul was recommended for all components, regardless of the flying hours for individual helicopters. All the rotors were disassembled and the hinge pins were inspected to ascertain the presence of cracks, corrosion pits and general corrosion. Those pins that were determined to be satisfactory for further use were stripped of cadmium, shot-peened, and re-coated with cadmium to a minimum thickness of 12.5 µm.
